# "Extensor Pollicis Longus Rupture Following Volar Locking Plate Fixation of a Distal End Radius Fracture"

DR ADITYA SETHI JUNIOR RESIDENT

DEPT OF ORTHOPAEDICS

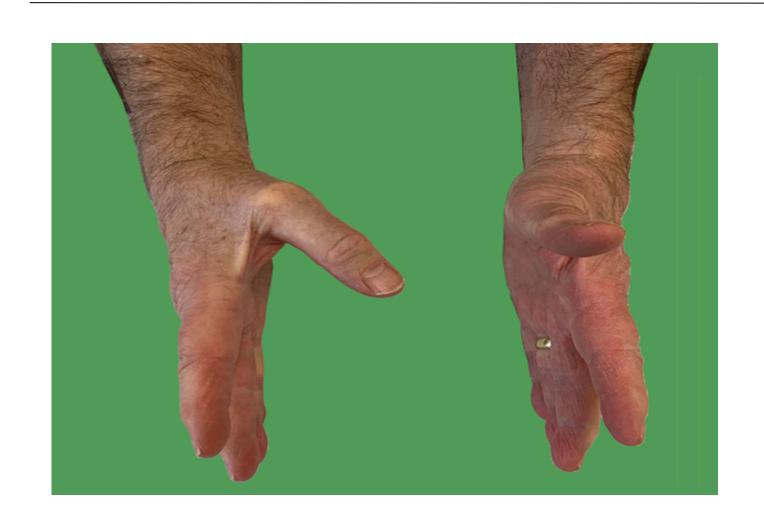
## CLINICAL RELEVANCE OF EPL

The problem most people have when the EPL tendon ruptures is loss of thumb extension and inability to easily get the hand around things like a glass or a handle. The hand does not open well.

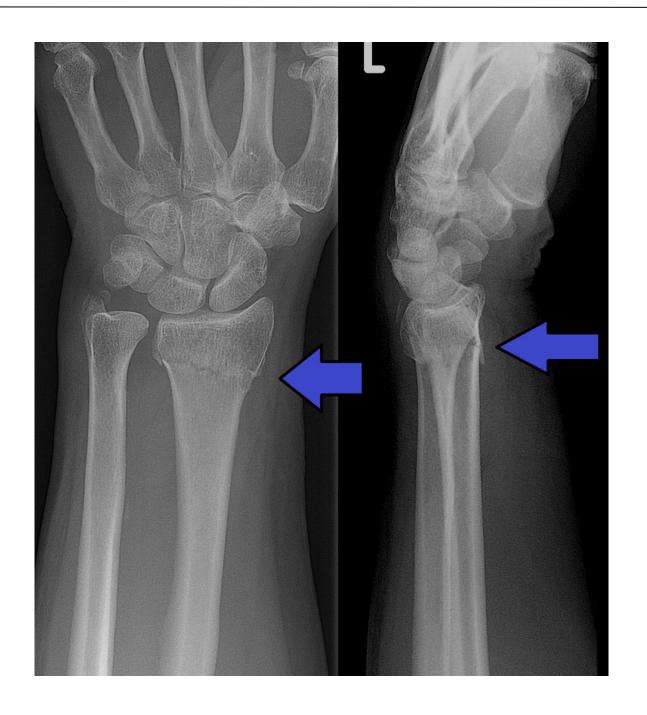
# PRE OP XRAY

Radiographs at this stage revealed dorsal prominence of screws, suggesting mechanical irritation of extensor tendons.

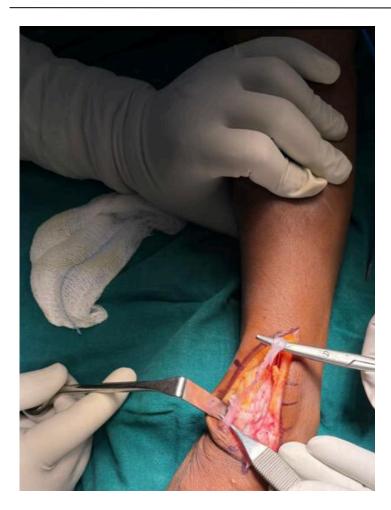
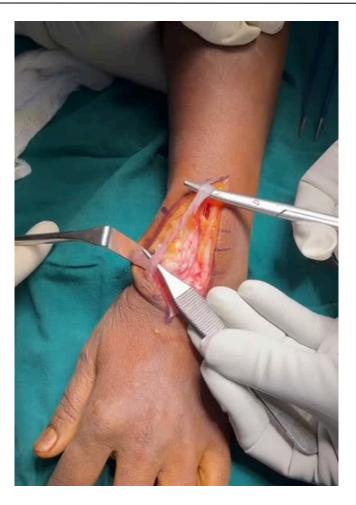
# OPERATIVE MANAGEMENT

Measurement of the EPL Tendon defect

- 1.Dorsal approach of wrist was taken and third compartment opened in line with EPL tendon and incision was extended proximally.
- 2. Attrition of EPL and EIP was observed.
- 3.On surgical exploration, complete attrition of EPL was observed. Additionally, attrition of EIP tendon (Extensor Indices Proprius) was also noted.

- Volarly 6-8 cm incision taken and modified Henry's approach was followed and the plate was exposed. Proximal and Distal screws removed using appropriate size screw drivers and the plate was removed.
- To address the functional loss of thumb extension, the proximal EIP tendon was transferred to EPL using Pulvertaft Technique and graft harvested.
- The remaining distal segment of EIP was attached to Extensor Digitorum (ED) using a side to end repair preserving the extension function of the index finger. Extensor Retinaculum was sutured.

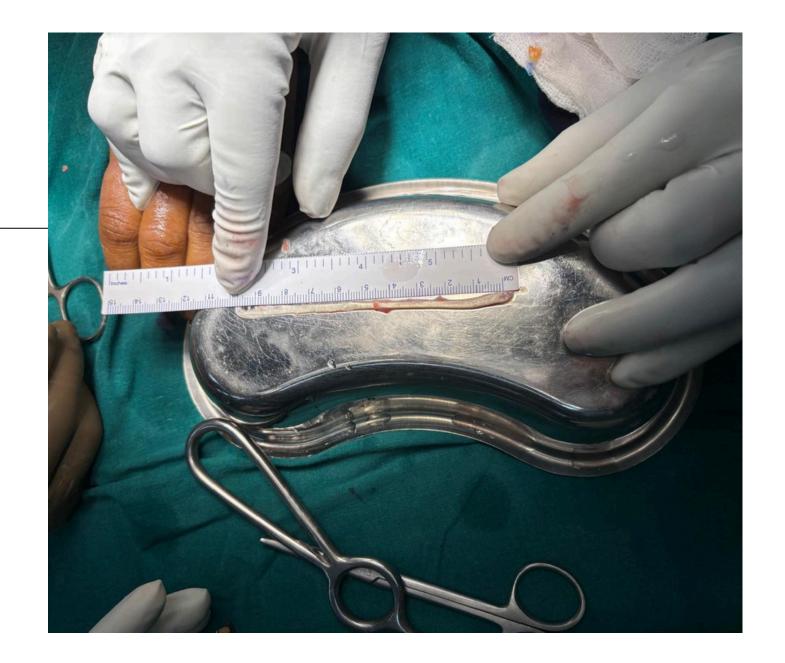
Measurement of graft size

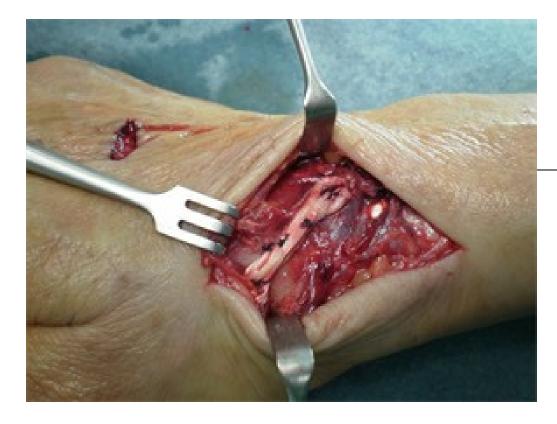
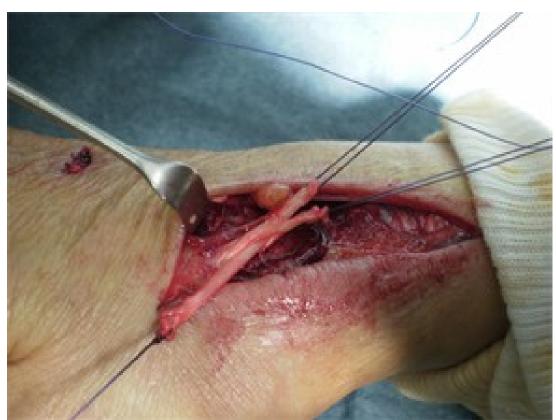
### Pulvertaft Weave Technique

- Donor tendon approaching the recipient tendon
- Recipient tendon has multiple horizontal slits or incisions
- Entry and exit points made using needle with suture for weaving
- Donor tendon is passed through the slits in recipient tendon in a woven or interlaced fashion.
  - Sutures placed to secure tendon in place
